Flood Control Project Maintenance
2019 Structure Summary Report
Overall Unit and Item Ratings

San Joaquin County Flood Control and Water Conservation District

Duck Creek Diversion Weir And Control Structure

Mormon Slough Pumping Plant No. 1

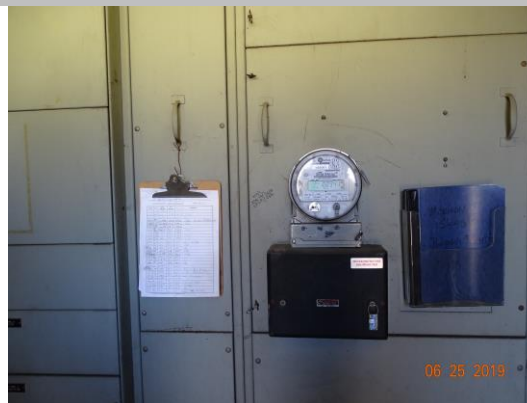
Photo 1 of 1 : ST_2019_NA0017_19_1_20190710_00015.jpg

| Inspector Comments: Operational log was present at the pump station. | | | | | |

View of operation log inside the pumping plant. Summer 2019

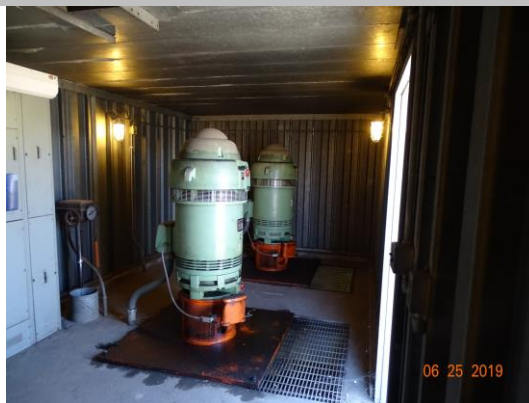
Photo 1 of 2 : ST_2019_NA0017_19_7_20190710_00019.jpg

| Inspector Comments: The pumps appeared to be well maintained and lubricated properly and the pumping system was tested periodically. | | | | | |

View of pumps inside the pumping plant. Summer 2019

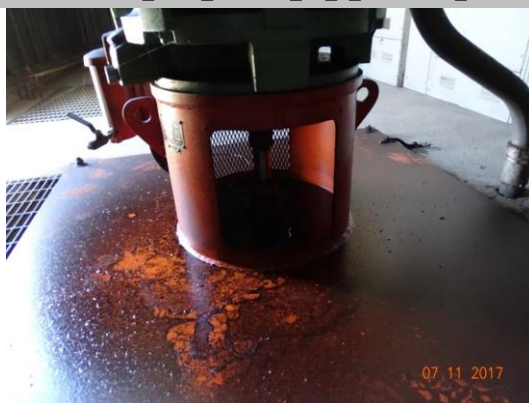
Photo 2 of 2 : ST_2019_NA0017_19_7_20190606_00006.jpg

View of the shaft under a pump.

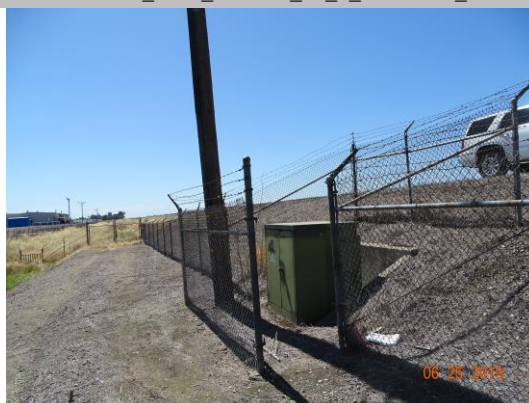
Photo 1 of 1 : ST_2019_NA0017_19_8_20190710_00020.jpg

| Inspector Comments: The power source appeared to be safe and reliable. | | | | | |

View of the power source for the pumping plant. Summer 2019

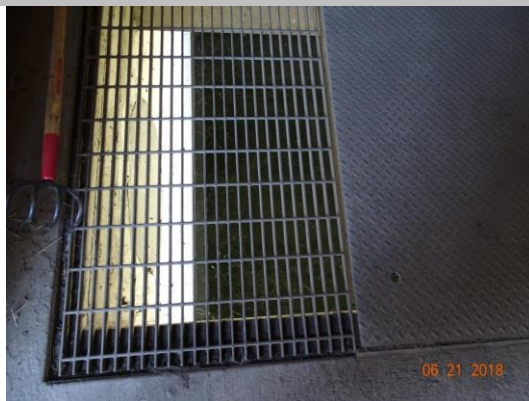
Photo 1 of 1 : ST_2019_NA0017_19_12_20190606_00010.jpg

| Inspector Comments: The wet well appeared to be clear of excessive debris or sediments. | | | | | |

View of the wet well.

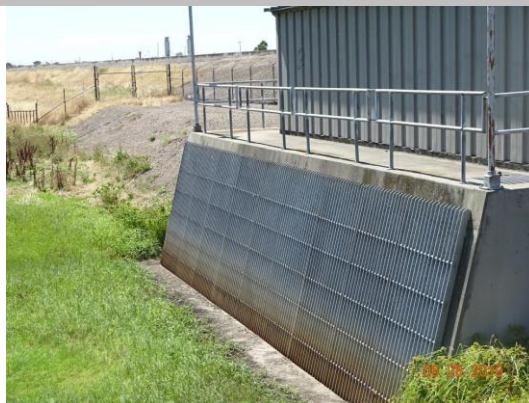
Photo 1 of 1 : ST_2019_NA0017_19_13_20190710_00021.jpg

| Inspector Comments: Trash racks were properly maintained and free of any debris. | | | | | |

View of the trash racks. Summer 2019

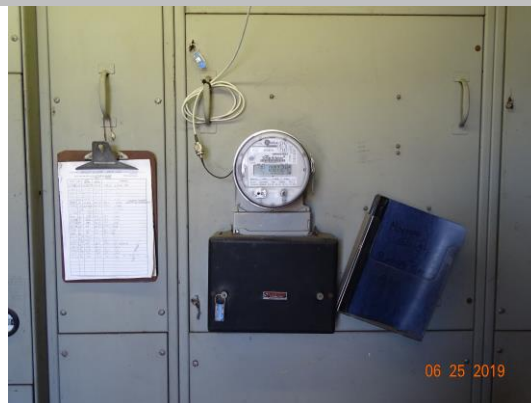
Photo 1 of 1 : ST_2019_NA0017_20_1_20190710_00014.jpg

| Inspector Comments: Maintenance log was present at the pumping plant. | | | | | |

View of the operating log inside the plant. Summer 2019

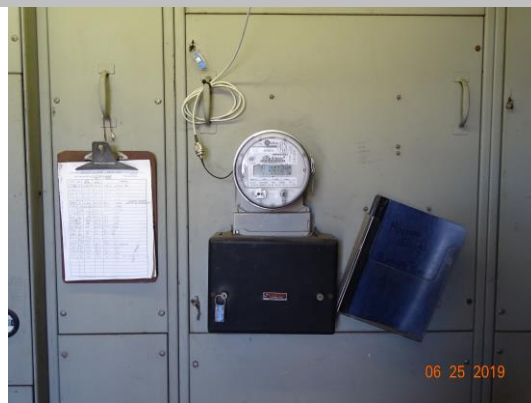
Photo 1 of 1 : ST_2019_NA0017_20_2_20190710_00015.jpg

| Inspector Comments: The O&M Manual was present at the pumping plant next to the operating log. | | | | | |

View of O&M manual inside the pumping plant. Summer 2019

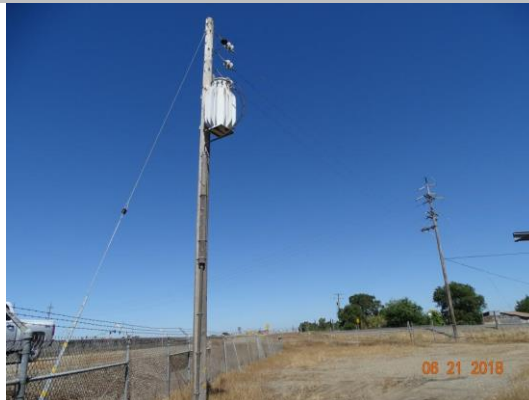
Photo 1 of 1 : ST_2019_NA0017_20_8_20190606_00007.jpg

| Inspector Comments: The power source appeared to be safe and reliable. | | | | | |

View of the power source for the pumping plant.

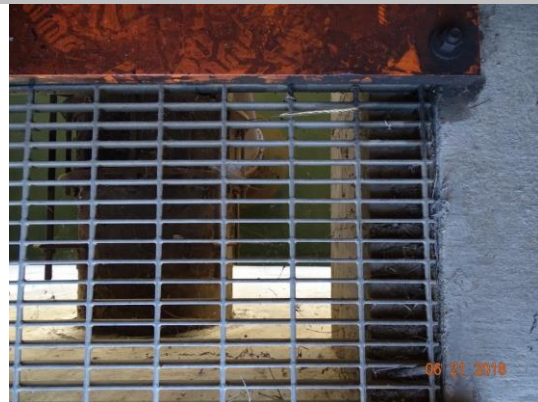
Photo 1 of 1 : ST_2019_NA0017_20_12_20190606_00009.jpg

| Inspector Comments: Wet well was clear of any excessive debris. | | | | | |

View of wet well inside the pumping plant.

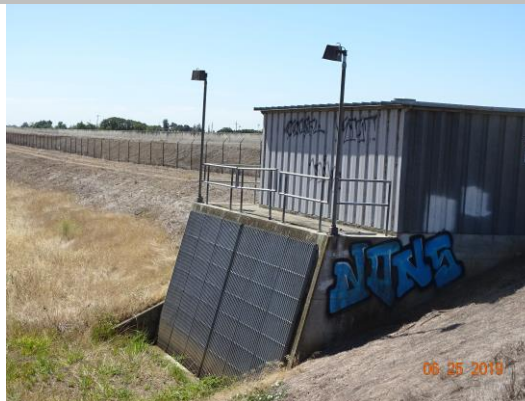
Photo 1 of 1 : ST_2019_NA0017_20_13_20190710_00019.jpg

| Inspector Comments: The trash racks were free of any debris. | | | | | | |

View of the trash racks. Summer 2019
